Manhole Inspection Report

Date:	04/27/2018	Weather:		Coding:	RZMACP
MH#:	M-606-079	Owner:	NA	Len. Surveyed:	7.8
P.O.#:		Surveyor:	Jen Costello	Rim to Invert:	8.2
Customer:		Cert. #:	U-907-5518	Wall Material:	Concrete (reinforced)

Street:	46' North of 7th St. East of Sunset St	Project:	Hobart, IN
City:	Hobart, IN	GPS Northing:	2902687.186
Location:		GPS Easting:	2902687.186
Drain Area:	Southwest	GPS Accuracy:	Sub-Meter
Cover Shape:	Circular	Evidence of Surcharge:	No
Cover Size:	22.5	Potential for Runoff:	None
Comments:

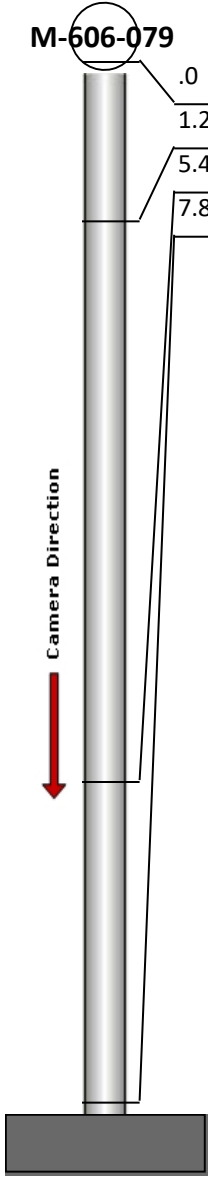
.0	MGO	General Observation	10	NA
	1.2	MGP	General Photo	26	NA
	5.4	DSF	Deposits Settled Fine	47	M 2
	7.8	MGO	General Observation	63	NA
