Manhole Inspection Report

| MH#: | M-606-090 | Owner: | NA | Len. Surveyed: | 12.5 |

| Street: | Lake Shore Dr. 164' West of Glendal | Project: | Hobart, IN |

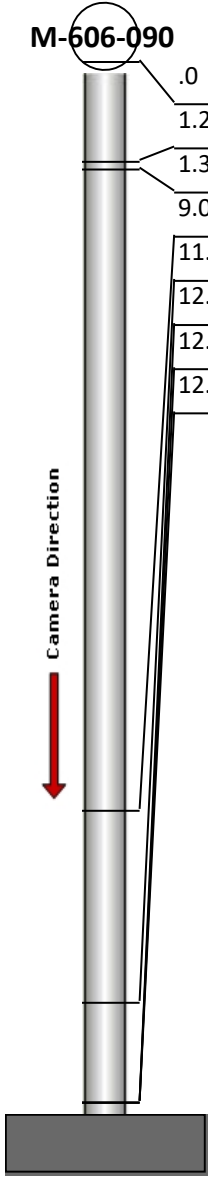
| | Position | Code | Observation | Video (sec) | Grade |
|--|---|---|---|---|---|
| | .0 | MGO | General Observation | 10 | NA |
| | 1.2 | SAV | Surface Aggregate Visible | 24 | S 3 |
| | 1.3 | MGO | General Observation | 38 | NA |
| | 9.0 | IW | Infil Weeper | 66 | M 2 |
| | 11.3 | OBZ | Obstacle Other | 82 | M 2 |
| | 12.5 | SAV | Surface Aggregate Visible | 96 | S 3 |
| | 12.5 | SAV | Surface Aggregate Visible | 107 | S 3 |
| | 12.5 | MGO | General Observation | 119 | NA |

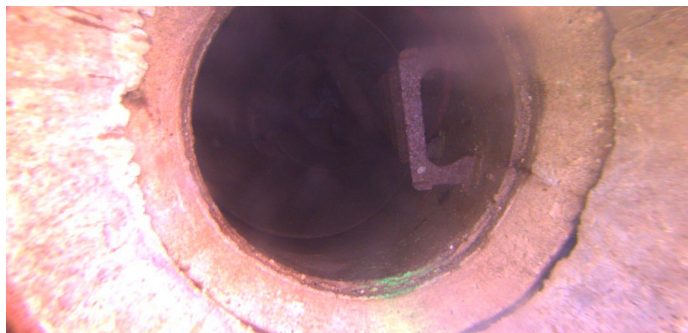
Code: **MGO**
Description: **General Observation**

Distance (ft): **.0**
Structural Grade: **0**
O&M Grade: **0**
Clock Start/From:
Clock To:
1st Value:
2nd Value:
Value Percent:
Step: **NO**
Remarks: **ACCESS MH**

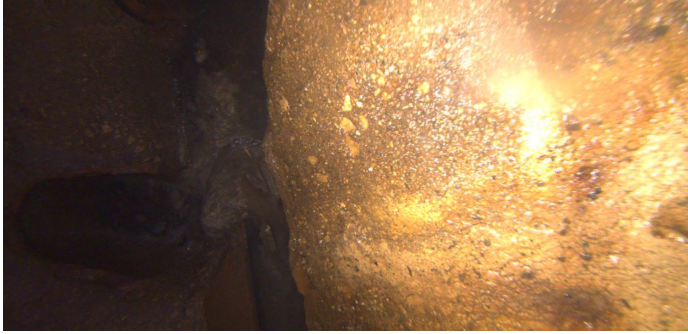
| Code: | MGO |
| Description: | General Observation |
