Manhole Inspection Report

Date:	04/08/2018	Weather:		Coding:	RZMACP
MH#:	M-607-001	Owner:	NA	Len. Surveyed:	13.1
P.O.#:		Surveyor:	John Kuglmaier	Rim to Invert:	13.5
Customer:		Cert. #:	U-1215-07002349	Wall Material:	Concrete (reinforced)

Street:	14th St. 331' West of Hwy 51.	Project:	Hobart, IN
City:	Hobart, IN	GPS Northing:	2904325.707
Location:		GPS Easting:	2904325.707
Drain Area:	Southwest	GPS Accuracy:	Sub-Meter
Cover Shape:	Circular	Evidence of Surcharge:	Yes
Cover Size:	22.5	Potential for Runoff:	None
Comments:

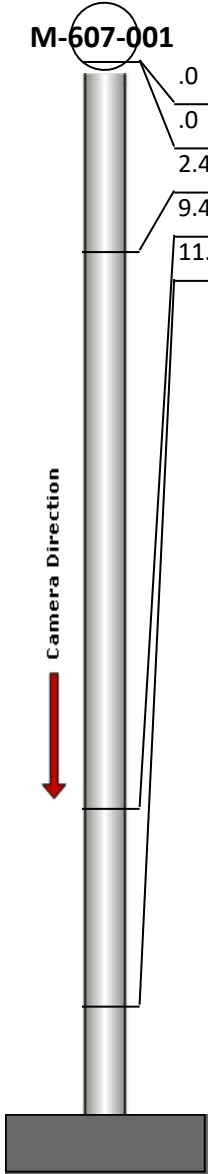
.0	MGP	General Photo	10	NA
	.0	RFJ	Roots Fine Joint	22	M 1
	2.4	MGP	General Photo	41	NA
	9.4	DAZ	Deposits Attached Other	68	M 3
	11.9	MGO	General Observation	85	NA
