Manhole Inspection Report

Date:	04/09/2018	Weather:		Coding:	RZMACP
MH#:	M-607-003	Owner:	NA	Len. Surveyed:	12.2
P.O.#:		Surveyor:	John Kuglmaier	Rim to Invert:	13.2
Customer:		Cert. #:	U-1215-07002349	Wall Material:	Concrete (reinforced)

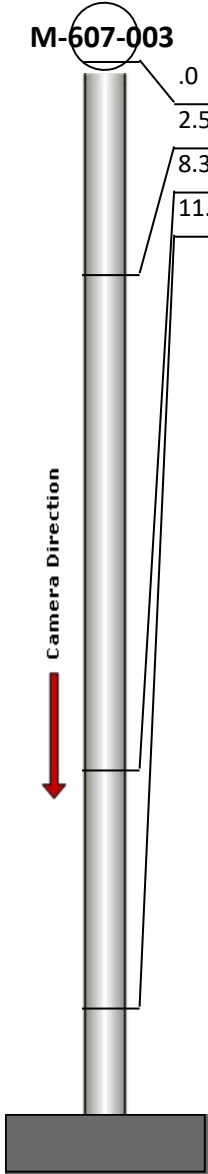
.0	MGP	General Photo	10	NA
	2.5	MGP	General Photo	29	NA
	8.3	DAZ	Deposits Attached Other	54	M 2
	11.1	MGO	General Observation	71	NA
