Manhole Inspection Report

Date:	04/26/2018	Weather:		Coding:	RZMACP
MH#:	M-607-010	Owner:	NA	Len. Surveyed:	15.6
P.O.#:		Surveyor:	Jen Costello	Rim to Invert:	15.5
Customer:		Cert. #:	U-907-5518	Wall Material:	Concrete (reinforced)

Street:	West of Lake Park Ave. 385' South of	Project:	Hobart, IN
City:	Hobart, IN	GPS Northing:	2904296.405
Location:		GPS Easting:	2904296.405
Drain Area:	Southwest	GPS Accuracy:	Sub-Meter
Cover Shape:	Circular	Evidence of Surcharge:	No
Cover Size:	22.5	Potential for Runoff:	None
Comments:

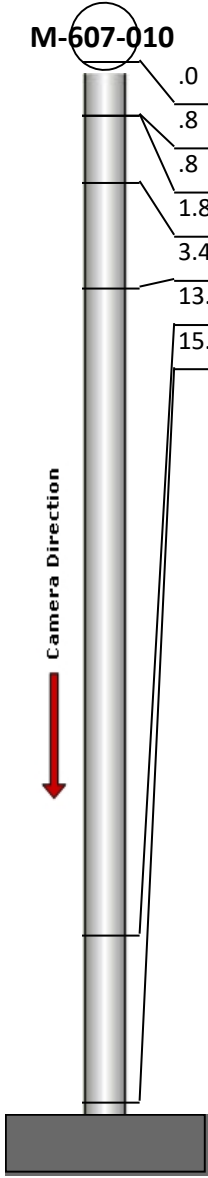
.0	MGO	General Observation	10	NA
	.8	FL	Fracture Longitudinal	23	S 3
	.8	CM	Crack Multiple	35	S 3
	1.8	MGP	General Photo	50	NA
	3.4	MGO	General Observation	66	NA
	13.1	DAR	Deposits Attached Ragging	97	M 2
	15.6	MGO	General Observation	114	NA
