Manhole Inspection Report

Date:	09/24/2022	Weather:		Coding:	RZMACP
MH#:	M-607-012	Owner:	NA	Len. Surveyed:	14.9
P.O.#:		Surveyor:	Jen Costello	Rim to Invert:	16.4
Customer:		Cert. #:	U-907-5518	Wall Material:	Concrete (cast in place)

Street:	West of Lake Park Ave. 185' South of	Project:	Hobart, IN
City:	Hobart, IN	GPS Northing:	2284978.098
Location:	Local Rural Streets	GPS Easting:	2904553.537
Drain Area:	Southwest	GPS Accuracy:	Sub-Meter
Cover Shape:	Circular	Evidence of Surcharge:	Yes
Cover Size:	24.0	Potential for Runoff:	None
Comments:

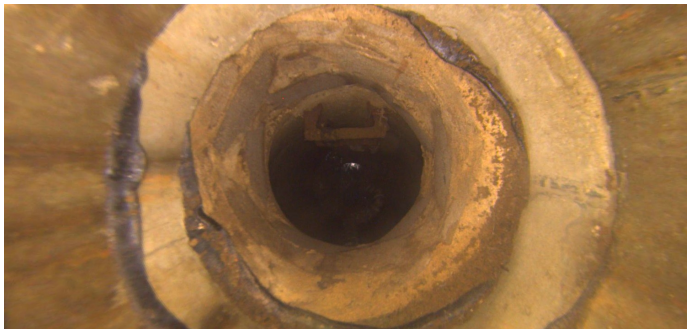
Code: **MGO**
Description: **General Observation**

Distance (ft): **.0**
Structural Grade: **0**
O&M Grade: **0**
Clock Start/From:
Clock To:
1st Value:
2nd Value:
Value Percent:
Step: **NO**
Remarks: **access mh**

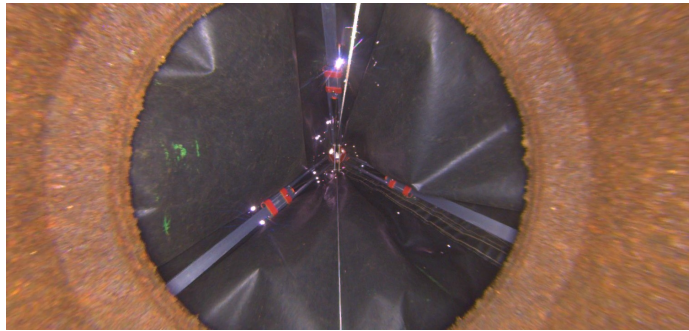
Code: **MGO**
Description: **General Observation**

Distance (ft): **1.1**
Structural Grade: **0**
O&M Grade: **0**
Clock Start/From:
Clock To:
1st Value:
2nd Value:
Value Percent:
Step: **NO**
Remarks: **underside of frame**

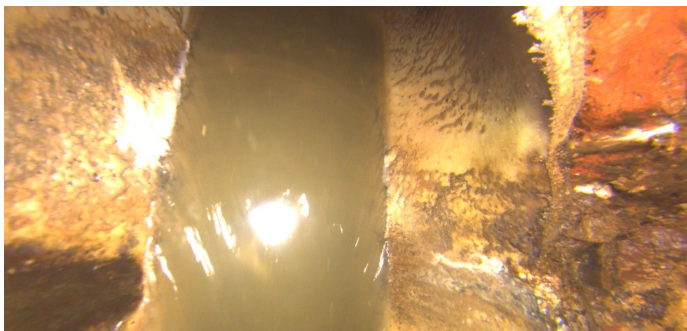
Code: **MGO**
Description: **General Observation**

Distance (ft): **14.8**
Structural Grade: **0**
O&M Grade: **0**
Clock Start/From:
Clock To:
1st Value:
2nd Value:
Value Percent:
Step: **NO**
Remarks: **end of survey**
