Manhole Inspection Report

Date:	04/25/2018	Weather:		Coding:	RZMACP
MH#:	M-607-016	Owner:	NA	Len. Surveyed:	8.7
P.O.#:		Surveyor:	John Kuglmaier	Rim to Invert:	8.7
Customer:	8.7	Cert. #:	U-1215-07002349	Wall Material:	Concrete (reinforced)

Street:	10th St. 727' East of Ash St.	Project:	Hobart, IN
City:	Hobart, IN	GPS Northing:	0.0
Location:		GPS Easting:	0.0
Drain Area:	Southwest	GPS Accuracy:	Nearest Meter
Cover Shape:	Circular	Evidence of Surcharge:	Yes
Cover Size:	22.5	Potential for Runoff:	None
Comments:

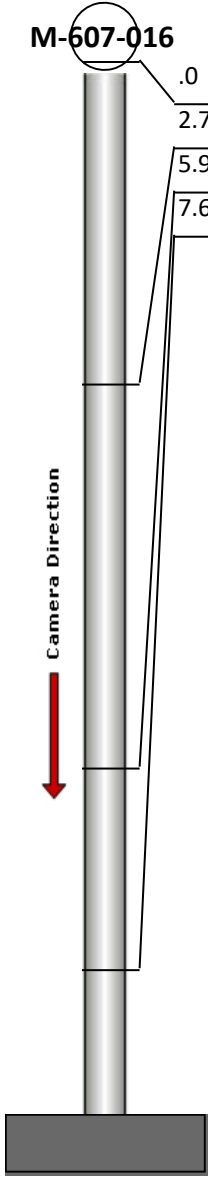
.0	MGP	General Photo	10	NA
	2.7	MGP	General Photo	29	NA
	5.9	DSF	Deposits Settled Fine	49	M 2
	7.6	MGO	General Observation	64	NA
