Manhole Inspection Report

Date:	04/25/2018	Weather:		Coding:	RZMACP
MH#:	M-607-017	Owner:	NA	Len. Surveyed:	12.1
P.O.#:		Surveyor:	John Kuglmaier	Rim to Invert:	11.8
Customer:	8.7	Cert. #:	U-1215-07002349	Wall Material:	Concrete (reinforced)

Street:	10th St. 306' East of Ash St.	Project:	Hobart, IN
City:	Hobart, IN	GPS Northing:	0.0
Location:		GPS Easting:	0.0
Drain Area:	Southwest	GPS Accuracy:	Nearest Meter
Cover Shape:	Circular	Evidence of Surcharge:	Yes
Cover Size:	22.5	Potential for Runoff:	None
Comments:

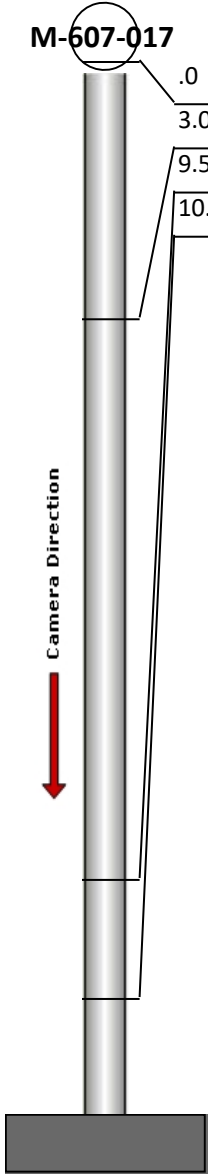
.0	MGP	General Photo	10	NA
	3.0	MGP	General Photo	30	NA
	9.5	DAZ	Deposits Attached Other	56	M 3
	10.9	MGO	General Observation	71	NA
