# Manhole Inspection Report

| MH#: | <b>M-607-018</b> | Owner: | <b>NA</b> | Len. Surveyed: | <b>12.4</b> |

| Street: | <b>10th St. 108' East of Ash St.</b> | Project: | <b>Hobart, IN</b> |

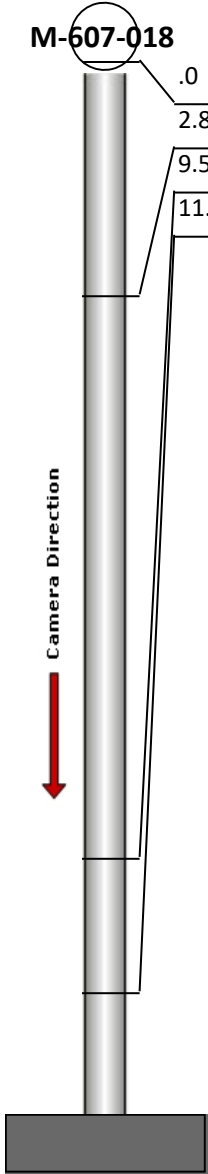
| | Position | Code | Observation | Video (sec) | Grade |
|--|---|---|---|---|---|
| | M-607-018 | | | | |

| | Position | Code | Observation | Video (sec) | Grade |
|--|---|---|---|---|---|
| | 9.5 | DAZ | Deposits Attached Other | 57 | M 2 |
| | 11.1 | MGO | General Observation | 72 | NA |
