Manhole Inspection Report

Date:	04/25/2018	Weather:		Coding:	RZMACP
MH#:	M-607-021	Owner:	NA	Len. Surveyed:	5.6
P.O.#:		Surveyor:	John Kuglmaier	Rim to Invert:	5.4
Customer:	8.7	Cert. #:	U-1215-07002349	Wall Material:	Concrete (reinforced)

Street:	Pennsylvania St. and 10th St.	Project:	Hobart, IN
City:	Hobart, IN	GPS Northing:	0.0
Location:		GPS Easting:	0.0
Drain Area:	Southwest	GPS Accuracy:	Nearest Meter
Cover Shape:	Circular	Evidence of Surcharge:	Yes
Cover Size:	22.5	Potential for Runoff:	None
Comments:

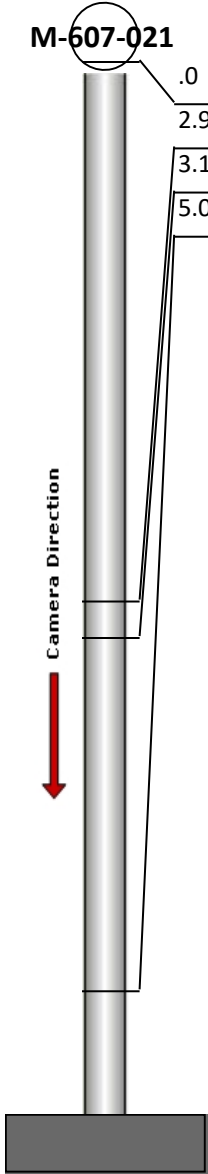
.0	MGP	General Photo	10	NA
	2.9	DSF	Deposits Settled Fine	27	M 2
	3.1	MGP	General Photo	42	NA
	5.0	MGO	General Observation	59	NA
