Manhole Inspection Report

Date:	04/25/2018	Weather:		Coding:	RZMACP
MH#:	M-607-022	Owner:	NA	Len. Surveyed:	9.5
P.O.#:		Surveyor:	John Kuglmaier	Rim to Invert:	9.3
Customer:	8.7	Cert. #:	U-1215-07002349	Wall Material:	Concrete (reinforced)

Street:	10th St. 336' East of Wisconsin St.	Project:	Hobart, IN
City:	Hobart, IN	GPS Northing:	0.0
Location:		GPS Easting:	0.0
Drain Area:	Southwest	GPS Accuracy:	Nearest Meter
Cover Shape:	Circular	Evidence of Surcharge:	Yes
Cover Size:	22.5	Potential for Runoff:	None
Comments:

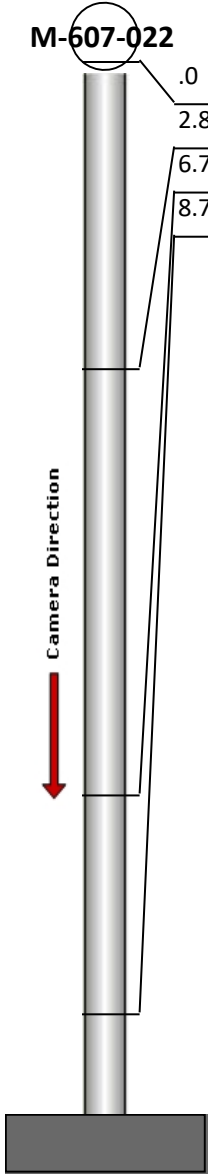
.0	MGP	General Photo	10	NA
	2.8	MGP	General Photo	29	NA
	6.7	DSF	Deposits Settled Fine	51	M 3
	8.7	MGO	General Observation	66	NA
