Manhole Inspection Report

Date:	04/06/2018	Weather:		Coding:	RZMACP
MH#:	M-607-030	Owner:	NA	Len. Surveyed:	9.1
P.O.#:		Surveyor:	John Kuglmaier	Rim to Invert:	9.7
Customer:		Cert. #:	U-1215-07002349	Wall Material:	Concrete (reinforced)

Street:	Laura Ln. 162' East of Laura Ct.	Project:	Hobart, IN
City:	Hobart, IN	GPS Northing:	0.0
Location:		GPS Easting:	0.0
Drain Area:	Southwest	GPS Accuracy:	Nearest Meter
Cover Shape:	Circular	Evidence of Surcharge:	No
Cover Size:	22.5	Potential for Runoff:	None
Comments:

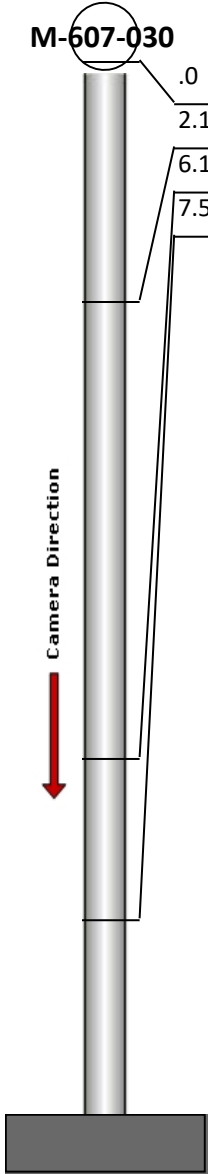
0.0	MGP	General Photo	10	NA
	2.1	MGP	General Photo	28	NA
	6.1	DAZ	Deposits Attached Other	50	M 2
	7.5	MGO	General Observation	64	NA
