Manhole Inspection Report

Date:	04/06/2018	Weather:		Coding:	RZMACP
MH#:	M-607-031	Owner:	NA	Len. Surveyed:	5.4
P.O.#:		Surveyor:	John Kuglmaier	Rim to Invert:	6.1
Customer:		Cert. #:	U-1215-07002349	Wall Material:	Concrete (reinforced)

Street:	Laura Ct. and Laura Ln. Slightly to th	Project:	Hobart, IN
City:	Hobart, IN	GPS Northing:	0.0
Location:		GPS Easting:	0.0
Drain Area:	Southwest	GPS Accuracy:	Nearest Meter
Cover Shape:	Circular	Evidence of Surcharge:	No
Cover Size:	22.5	Potential for Runoff:	None
Comments:

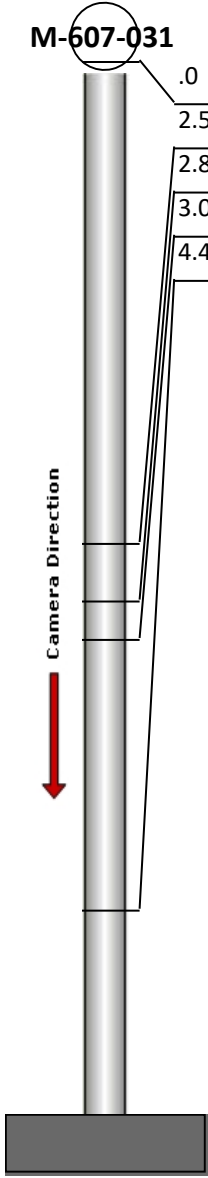
.0	MGP	General Photo	10	NA
	2.5	MGP	General Photo	29	NA
	2.8	DAZ	Deposits Attached Other	43	M 3
	3.0	IS	Infil Stain	55	NA
	4.4	MGO	General Observation	70	NA
