Manhole Inspection Report

Date:	04/04/2018	Weather:		Coding:	RZMACP
MH#:	M-607-048	Owner:	NA	Len. Surveyed:	9.3
P.O.#:		Surveyor:	John Kuglmaier	Rim to Invert:	9.6
Customer:		Cert. #:	U-1215-07002349	Wall Material:	Concrete (reinforced)

Street:	Medlee Dr. 316' North of Fatima Ln.	Project:	Hobart, IN
City:	Hobart, IN	GPS Northing:	0.0
Location:		GPS Easting:	0.0
Drain Area:	Southwest	GPS Accuracy:	Nearest Meter
Cover Shape:	Circular	Evidence of Surcharge:	No
Cover Size:	22.5	Potential for Runoff:	None
Comments:

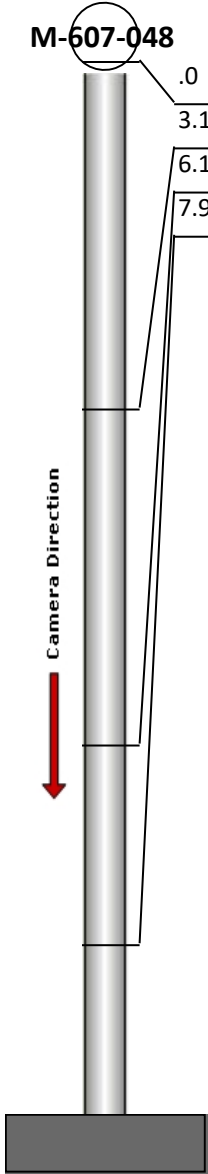
.0	MGP	General Photo	10	NA
	3.1	MGP	General Photo	30	NA
	6.1	DSF	Deposits Settled Fine	50	M 2
	7.9	MGO	General Observation	65	NA
