Manhole Inspection Report

Date:	04/04/2018	Weather:		Coding:	RZMACP
MH#:	M-607-055	Owner:	NA	Len. Surveyed:	6.1
P.O.#:		Surveyor:	John Kuglmaier	Rim to Invert:	6.3
Customer:		Cert. #:	U-1215-07002349	Wall Material:	Concrete (reinforced)

Street:	Wisconsin St. 385' North of 14th St.	Project:	Hobart, IN
City:	Hobart, IN	GPS Northing:	0.0
Location:		GPS Easting:	0.0
Drain Area:	Southwest	GPS Accuracy:	Nearest Meter
Cover Shape:	Circular	Evidence of Surcharge:	No
Cover Size:	22.5	Potential for Runoff:	None
Comments:

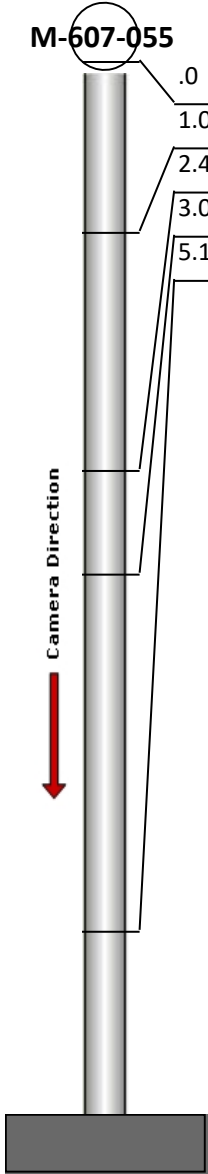
.0	MGP	General Photo	10	NA
	1.0	IS	Infil Stain	24	NA
	2.4	MGP	General Photo	41	NA
	3.0	DAZ	Deposits Attached Other	56	M 2
	5.1	MGO	General Observation	71	NA
