Manhole Inspection Report

Date:	03/28/2018	Weather:		Coding:	RZMACP
MH#:	M-607-058	Owner:	NA	Len. Surveyed:	4.1
P.O.#:		Surveyor:	John Kuglmaier	Rim to Invert:	5.0
Customer:		Cert. #:	U-1215-07002349	Wall Material:	Concrete (reinforced)

Street:	Wisconsin St. 132' North of Morning	Project:	Hobart, IN
City:	Hobart, IN	GPS Northing:	0.0
Location:		GPS Easting:	0.0
Drain Area:	Southwest	GPS Accuracy:	Nearest Meter
Cover Shape:	Circular	Evidence of Surcharge:	No
Cover Size:	22.5	Potential for Runoff:	None
Comments:

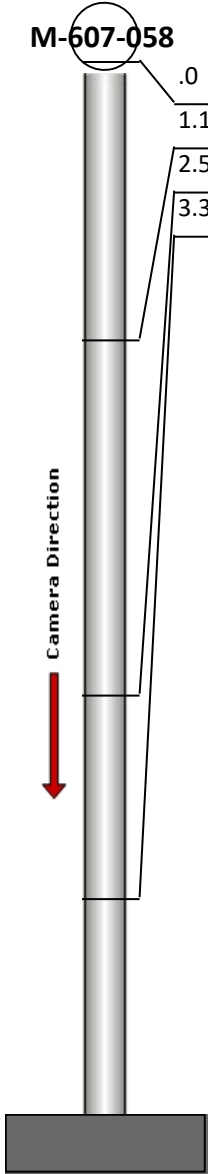
.0	MGP	General Photo	10	NA
	1.1	DSF	Deposits Settled Fine	24	M 2
	2.5	MGP	General Photo	40	NA
	3.3	MGO	General Observation	55	NA
