Manhole Inspection Report

Date:	04/04/2018	Weather:		Coding:	RZMACP
MH#:	M-607-069	Owner:	NA	Len. Surveyed:	4.9
P.O.#:		Surveyor:	John Kuglmaier	Rim to Invert:	5.6
Customer:		Cert. #:	U-1215-07002349	Wall Material:	Concrete (reinforced)

Street:	Medlee Dr. 254' North of Diana Ct.	Project:	Hobart, IN
City:	Hobart, IN	GPS Northing:	0.0
Location:		GPS Easting:	0.0
Drain Area:	Southwest	GPS Accuracy:	Nearest Meter
Cover Shape:	Circular	Evidence of Surcharge:	No
Cover Size:	22.5	Potential for Runoff:	None
Comments:

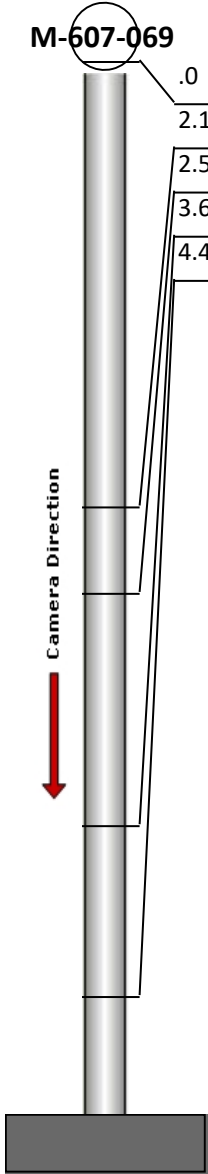
Position	Code	Observation	Video (sec)	Grade

.0	MGP	General Photo	10	NA
	2.1	DAZ	Deposits Attached Other	26	M 2
	2.5	MGP	General Photo	40	NA
	3.6	IS	Infil Stain	56	NA
	4.4	MGO	General Observation	70	NA
