Manhole Inspection Report

Date:	04/25/2018	Weather:		Coding:	RZMACP
MH#:	M-607-071	Owner:	NA	Len. Surveyed:	8.8
P.O.#:		Surveyor:	John Kuglmaier	Rim to Invert:	9.3
Customer:	8.7	Cert. #:	U-1215-07002349	Wall Material:	Concrete (reinforced)

Street:	10th St. 287' West of Pennsylvania S	Project:	Hobart, IN
City:	Hobart, IN	GPS Northing:	0.0
Location:		GPS Easting:	0.0
Drain Area:	Southwest	GPS Accuracy:	Nearest Meter
Cover Shape:	Circular	Evidence of Surcharge:	Yes
Cover Size:	22.5	Potential for Runoff:	None
Comments:

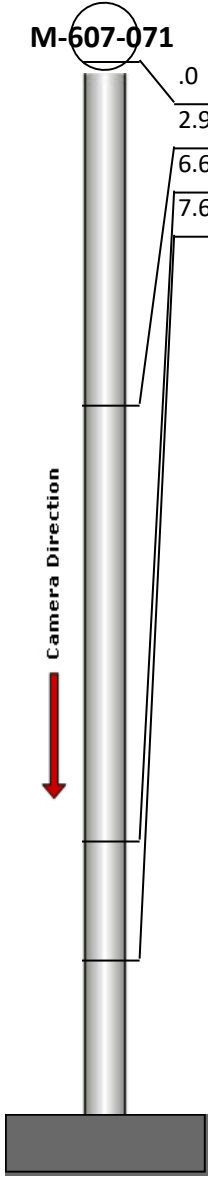
M-607-071				
	.0	MGP	General Photo	10	NA
	2.9	MGP	General Photo	30	NA
	6.6	DSF	Deposits Settled Fine	51	M 2
	7.6	MGO	General Observation	64	NA
