Manhole Inspection Report

Date:	04/05/2018	Weather:		Coding:	RZMACP
MH#:	M-607-072	Owner:	NA	Len. Surveyed:	5.7
P.O.#:		Surveyor:	John Kuglmaier	Rim to Invert:	6.7
Customer:		Cert. #:	U-1215-07002349	Wall Material:	Concrete (reinforced)

Street:	On Ash St. 384' North of 14th St.	Project:	Hobart, IN
City:	Hobart, IN	GPS Northing:	0.0
Location:		GPS Easting:	0.0
Drain Area:	Southwest	GPS Accuracy:	Nearest Meter
Cover Shape:	Circular	Evidence of Surcharge:	No
Cover Size:	22.5	Potential for Runoff:	None
Comments:

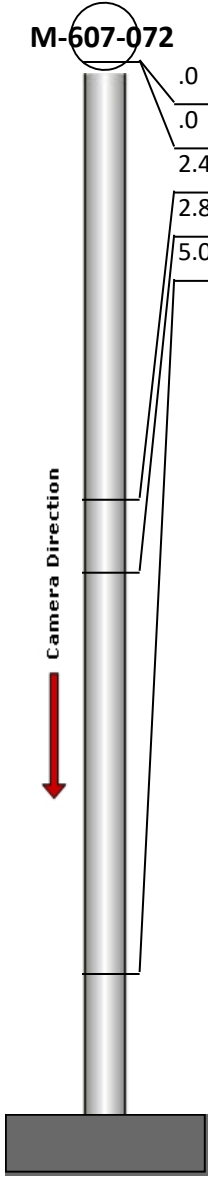
.0	MGP	General Photo	10	NA
	.0	RFJ	Roots Fine Joint	22	M 1
	2.4	MGP	General Photo	41	NA
	2.8	DSF	Deposits Settled Fine	55	M 2
	5.0	MGO	General Observation	71	NA
