Manhole Inspection Report

Date:	04/06/2018	Weather:		Coding:	RZMACP
MH#:	M-607-073	Owner:	NA	Len. Surveyed:	4.3
P.O.#:		Surveyor:	John Kuglmaier	Rim to Invert:	5.9
Customer:		Cert. #:	U-1215-07002349	Wall Material:	Concrete (reinforced)

Street:	290' West of Ash St. 209' North of 1	Project:	Hobart, IN
City:	Hobart, IN	GPS Northing:	0.0
Location:		GPS Easting:	0.0
Drain Area:	Southwest	GPS Accuracy:	Nearest Meter
Cover Shape:	Circular	Evidence of Surcharge:	Yes
Cover Size:	22.5	Potential for Runoff:	None
Comments:

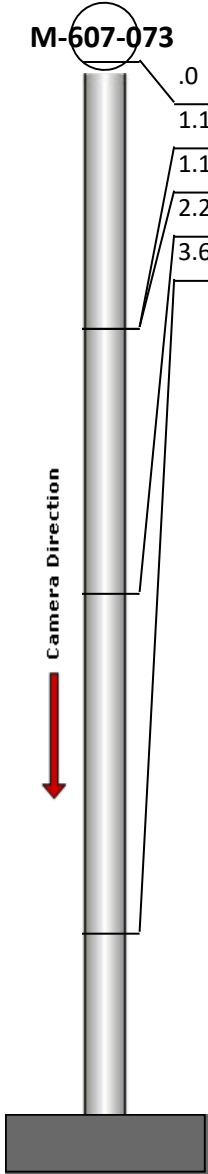
.0	MGP	General Photo	10	NA
	1.1	IS	Infil Stain	24	NA
	1.1	IS	Infil Stain	36	NA
	2.2	MGP	General Photo	52	NA
	3.6	MGO	General Observation	68	NA
