Manhole Inspection Report

Date:	04/25/2018	Weather:		Coding:	RZMACP
MH#:	M-607-078	Owner:	NA	Len. Surveyed:	12.1
P.O.#:		Surveyor:	John Kuglmaier	Rim to Invert:	12.1
Customer:	8.7	Cert. #:	U-1215-07002349	Wall Material:	Concrete (reinforced)

Street:	Ash St. 165' South of 10th St.	Project:	Hobart, IN
City:	Hobart, IN	GPS Northing:	0.0
Location:		GPS Easting:	0.0
Drain Area:	Southwest	GPS Accuracy:	Nearest Meter
Cover Shape:	Circular	Evidence of Surcharge:	No
Cover Size:	22.5	Potential for Runoff:	None
Comments:

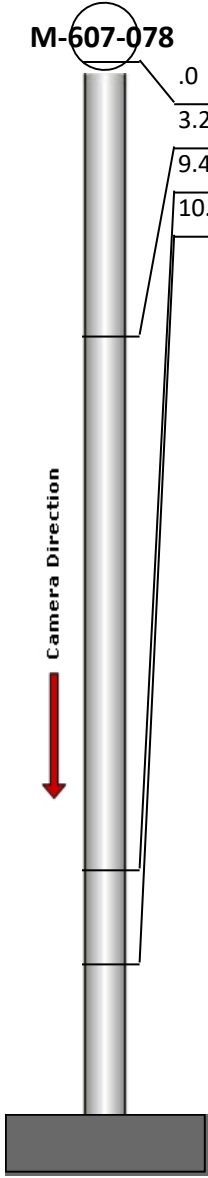
.0	MGP	General Photo	10	NA
	3.2	MGP	General Photo	30	NA
	9.4	DSF	Deposits Settled Fine	56	M 2
	10.5	MGO	General Observation	70	NA
