Manhole Inspection Report

Date:	04/25/2018	Weather:		Coding:	RZMACP
MH#:	M-607-079	Owner:	NA	Len. Surveyed:	11.2
P.O.#:		Surveyor:	John Kuglmaier	Rim to Invert:	11.4
Customer:	8.7	Cert. #:	U-1215-07002349	Wall Material:	Concrete (reinforced)

Street:	Ash St. 700' South of 10th St.	Project:	Hobart, IN
City:	Hobart, IN	GPS Northing:	0.0
Location:		GPS Easting:	0.0
Drain Area:	Southwest	GPS Accuracy:	Nearest Meter
Cover Shape:	Circular	Evidence of Surcharge:	No
Cover Size:	22.5	Potential for Runoff:	None
Comments:

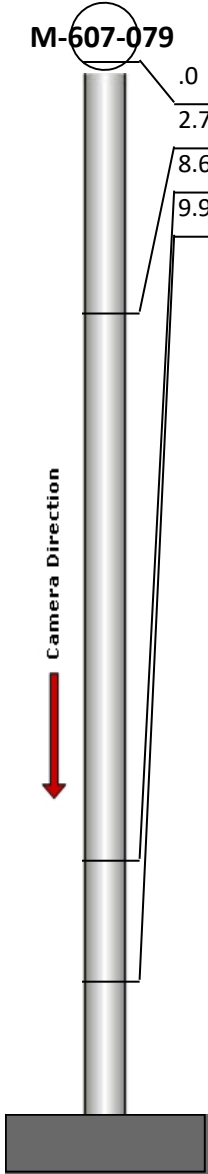
.0	MGP	General Photo	10	NA
	2.7	MGP	General Photo	29	NA
	8.6	DSF	Deposits Settled Fine	55	M 2
	9.9	MGO	General Observation	69	NA
