Manhole Inspection Report

Date:	04/07/2018	Weather:		Coding:	RZMACP
MH#:	M-608-008	Owner:	NA	Len. Surveyed:	5.7
P.O.#:		Surveyor:	John Kuglmaier	Rim to Invert:	6.1
Customer:		Cert. #:	U-1215-07002349	Wall Material:	Concrete (reinforced)

Street:	296' South of 61st Ave. 491' West of	Project:	Hobart, IN
City:	Hobart, IN	GPS Northing:	0.0
Location:		GPS Easting:	0.0
Drain Area:	Southwest	GPS Accuracy:	Nearest Meter
Cover Shape:	Circular	Evidence of Surcharge:	No
Cover Size:	22.5	Potential for Runoff:	None
Comments:

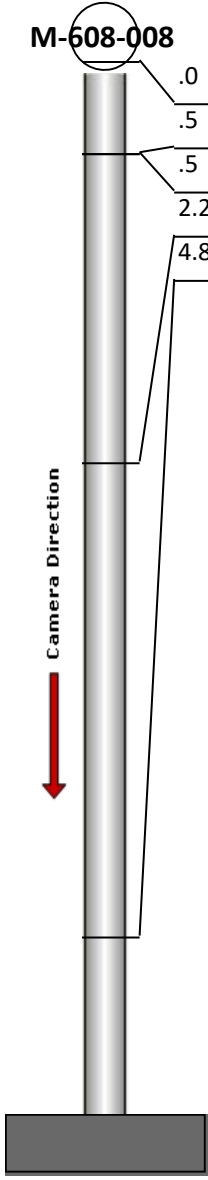
.0	MGP	General Photo	10	NA
	.5	IS	Infil Stain	23	NA
	.5	IS	Infil Stain	34	NA
	2.2	MGP	General Photo	51	NA
	4.8	MGO	General Observation	70	NA
