Manhole Inspection Report

Date:	04/07/2018	Weather:		Coding:	RZMACP
MH#:	M-608-010	Owner:	NA	Len. Surveyed:	7.6
P.O.#:		Surveyor:	John Kuglmaier	Rim to Invert:	7.0
Customer:		Cert. #:	U-1215-07002349	Wall Material:	Concrete (reinforced)

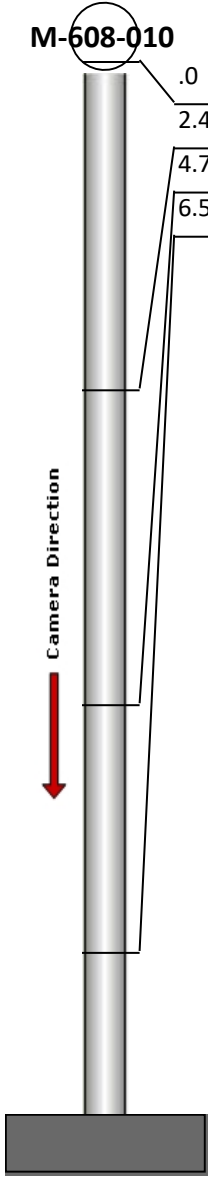
.0	MGP	General Photo	10	NA
	2.4	MGP	General Photo	29	NA
	4.7	DSF	Deposits Settled Fine	47	M 2
	6.5	MGO	General Observation	62	NA
