Manhole Inspection Report

Date:	04/08/2018	Weather:		Coding:	RZMACP
MH#:	M-608-013	Owner:	NA	Len. Surveyed:	8.5
P.O.#:		Surveyor:	John Kuglmaier	Rim to Invert:	8.6
Customer:		Cert. #:	U-1215-07002349	Wall Material:	Concrete (reinforced)

Street:	On West 61st St. 464' North of 61st	Project:	Hobart, IN
City:	Hobart, IN	GPS Northing:	2903321.006
Location:		GPS Easting:	2903321.006
Drain Area:	Southwest	GPS Accuracy:	Sub-Meter
Cover Shape:	Circular	Evidence of Surcharge:	Yes
Cover Size:	22.5	Potential for Runoff:	None
Comments:

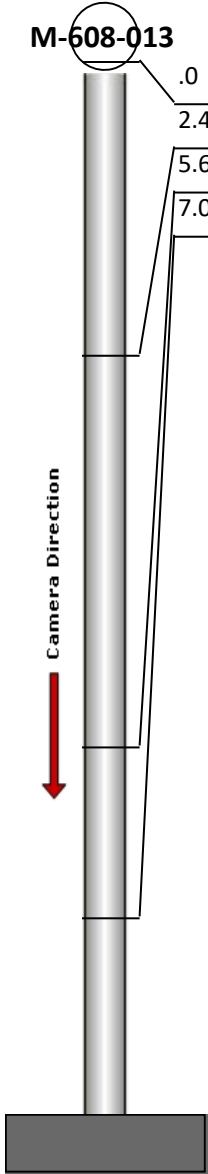
.0	MGP	General Photo	10	NA
	2.4	MGP	General Photo	29	NA
	5.6	DAZ	Deposits Attached Other	49	M 2
	7.0	MGO	General Observation	63	NA
