Manhole Inspection Report

Date:	04/06/2018	Weather:		Coding:	RZMACP
MH#:	M-608-022	Owner:	NA	Len. Surveyed:	10.5
P.O.#:		Surveyor:	John Kuglmaier	Rim to Invert:	11.5
Customer:		Cert. #:	U-1215-07002349	Wall Material:	Concrete (reinforced)

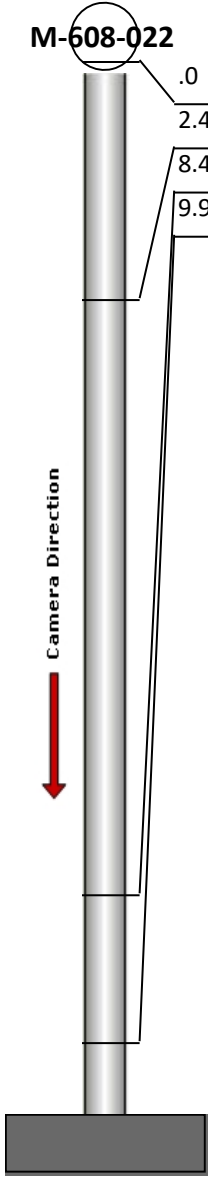
M-608-022				
	.0	MGP	General Photo	10	NA
	2.4	MGP	General Photo	29	NA
	8.4	DAZ	Deposits Attached Other	54	M 3
	9.9	MGO	General Observation	69	NA
