Manhole Inspection Report

Date:	04/08/2018	Weather:		Coding:	RZMACP
MH#:	M-608-024	Owner:	NA	Len. Surveyed:	6.8
P.O.#:		Surveyor:	John Kuglmaier	Rim to Invert:	7.3
Customer:		Cert. #:	U-1215-07002349	Wall Material:	Concrete (reinforced)

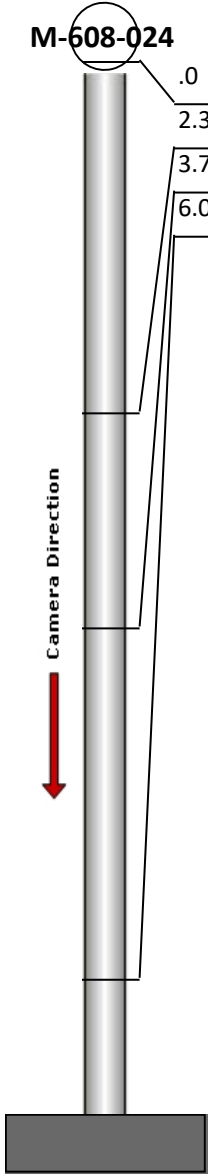
.0	MGP	General Photo	10	NA
	2.3	MGP	General Photo	28	NA
	3.7	DSF	Deposits Settled Fine	45	M 2
	6.0	MGO	General Observation	61	NA
