Manhole Inspection Report

Date:	04/08/2018	Weather:		Coding:	RZMACP
MH#:	M-608-031	Owner:	NA	Len. Surveyed:	4.1
P.O.#:		Surveyor:	John Kuglmaier	Rim to Invert:	7.9
Customer:		Cert. #:	U-1215-07002349	Wall Material:	Concrete (reinforced)

Street:	238' South of 14th St. 665' West of	Project:	Hobart, IN
City:	Hobart, IN	GPS Northing:	2904008.971
Location:		GPS Easting:	2904008.971
Drain Area:	Southwest	GPS Accuracy:	Sub-Meter
Cover Shape:	Circular	Evidence of Surcharge:	Yes
Cover Size:	22.5	Potential for Runoff:	None
Comments:

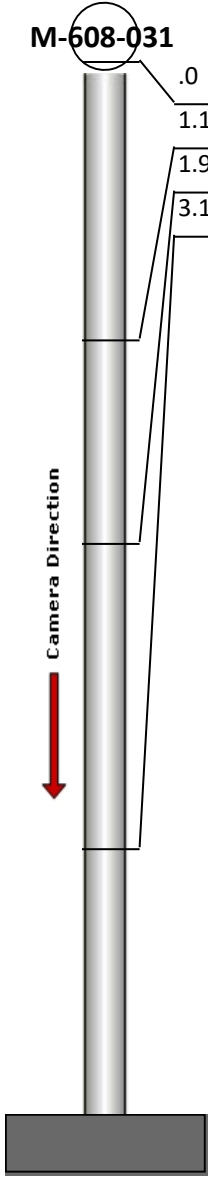
.0	MGP	General Photo	10	NA
	1.1	MGO	General Observation	24	NA
	1.9	MGP	General Photo	39	NA
	3.1	MSA	Abandoned Survey	55	NA
