Manhole Inspection Report

Date:	04/06/2018	Weather:		Coding:	RZMACP
MH#:	M-608-039	Owner:	NA	Len. Surveyed:	6.7
P.O.#:		Surveyor:	John Kuglmaier	Rim to Invert:	7.5
Customer:		Cert. #:	U-1215-07002349	Wall Material:	Concrete (reinforced)

Street:	On Washington St. 366' North of 61s	Project:	Hobart, IN
City:	Hobart, IN	GPS Northing:	0.0
Location:		GPS Easting:	0.0
Drain Area:	Southwest	GPS Accuracy:	Nearest Meter
Cover Shape:	Circular	Evidence of Surcharge:	No
Cover Size:	22.5	Potential for Runoff:	None
Comments:

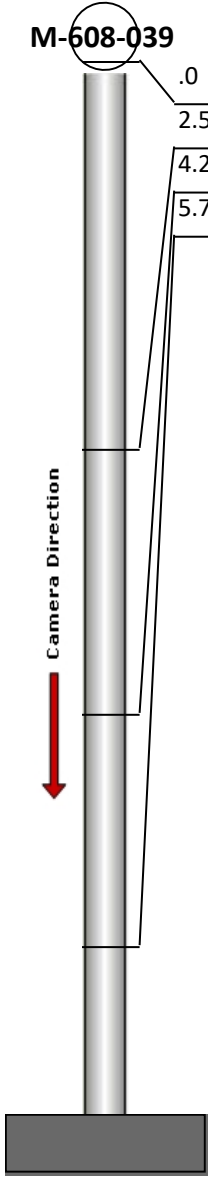
.0	MGP	General Photo	10	NA
	2.5	MGP	General Photo	29	NA
	4.2	DSGV	Deposits Settled Gravel	46	M 2
	5.7	MGO	General Observation	60	NA
