Manhole Inspection Report

Date:	03/26/2018	Weather:		Coding:	RZMACP
MH#:	M-703-004	Owner:	NA	Len. Surveyed:	9.5
P.O.#:		Surveyor:	John Kuglmaier	Rim to Invert:	11.2
Customer:		Cert. #:	U-1215-07002349	Wall Material:	Concrete (reinforced)

Street:	East Pheasant Run Dr. 284' West of	Project:	Hobart, IN
City:	Hobart, IN	GPS Northing:	0.0
Location:		GPS Easting:	0.0
Drain Area:	North	GPS Accuracy:	Nearest Meter
Cover Shape:	Circular	Evidence of Surcharge:	No
Cover Size:	23.0	Potential for Runoff:	None
Comments:

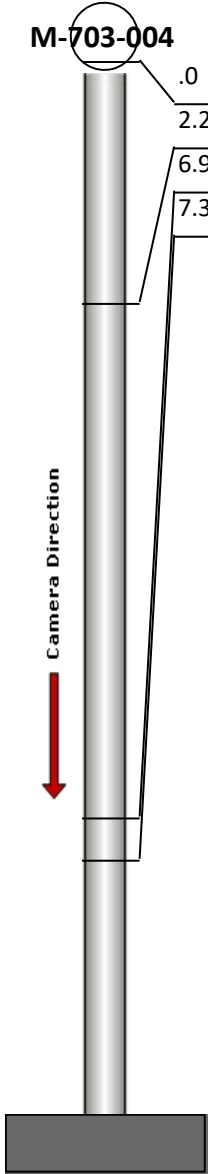
.0	MGP	General Photo	10	NA
	2.2	MGP	General Photo	28	NA
	6.9	DSGV	Deposits Settled Gravel	51	M 2
	7.3	MGO	General Observation	64	NA
