Manhole Inspection Report

Date:	03/26/2018	Weather:		Coding:	RZMACP
MH#:	M-703-009	Owner:	NA	Len. Surveyed:	8.4
P.O.#:		Surveyor:	John Kuglmaier	Rim to Invert:	10.3
Customer:		Cert. #:	U-1215-07002349	Wall Material:	Concrete (reinforced)

Street:	291' West of Quail Dr.	Project:	Hobart, IN
City:	Hobart, IN	GPS Northing:	0.0
Location:		GPS Easting:	0.0
Drain Area:	North	GPS Accuracy:	Nearest Meter
Cover Shape:	Circular	Evidence of Surcharge:	No
Cover Size:	23.0	Potential for Runoff:	None
Comments:

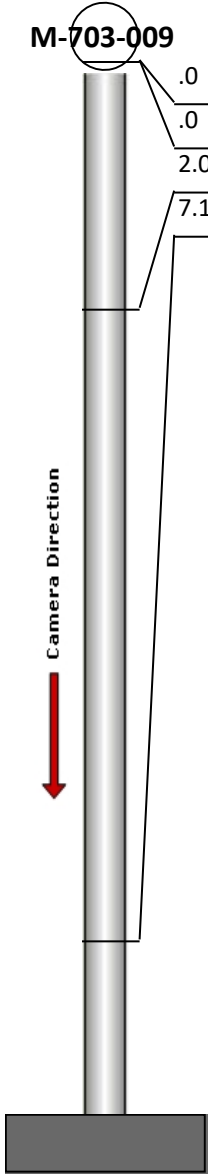
M-703-009				
	.0	MGP	General Photo	10	NA
	.0	RFJ	Roots Fine Joint	22	M 1
	2.0	MGP	General Photo	40	NA
	7.1	MGO	General Observation	64	NA
