Manhole Inspection Report

Date:	03/26/2018	Weather:		Coding:	RZMACP
MH#:	M-703-020	Owner:	NA	Len. Surveyed:	11.7
P.O.#:		Surveyor:	John Kuglmaier	Rim to Invert:	12.8
Customer:		Cert. #:	U-1215-07002349	Wall Material:	Concrete (reinforced)

Street:	Hidden Lake Dr. 131' West of Quail	Project:	Hobart, IN
City:	Hobart, IN	GPS Northing:	0.0
Location:		GPS Easting:	0.0
Drain Area:	North	GPS Accuracy:	Nearest Meter
Cover Shape:	Circular	Evidence of Surcharge:	No
Cover Size:	23.0	Potential for Runoff:	None
Comments:

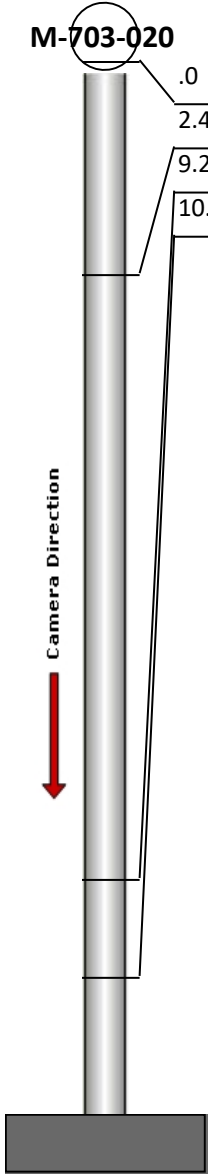
M-703-020				
	.0	MGP	General Photo	10	NA
	2.4	MGP	General Photo	28	NA
	9.2	DAZ	Deposits Attached Other	56	M 2
	10.3	MGO	General Observation	69	NA
