Manhole Inspection Report

Date:	03/29/2018	Weather:		Coding:	RZMACP
MH#:	M-703-022	Owner:	NA	Len. Surveyed:	7.6
P.O.#:		Surveyor:	John Kuglmaier	Rim to Invert:	8.9
Customer:		Cert. #:	U-1215-07002349	Wall Material:	Concrete (reinforced)

Street:	Hidden Lake Dr. 37' West of North P	Project:	Hobart, IN
City:	Hobart, IN	GPS Northing:	0.0
Location:		GPS Easting:	0.0
Drain Area:	North	GPS Accuracy:	Nearest Meter
Cover Shape:	Circular	Evidence of Surcharge:	No
Cover Size:	23.0	Potential for Runoff:	None
Comments:

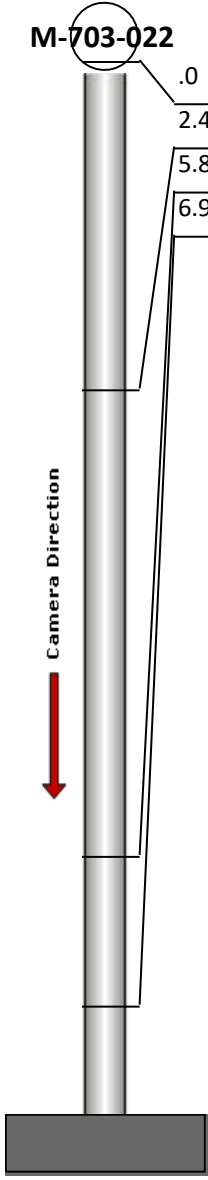
.0	MGP	General Photo	10	NA
	2.4	MGP	General Photo	29	NA
	5.8	DAZ	Deposits Attached Other	49	M 2
	6.9	MGO	General Observation	63	NA
