Manhole Inspection Report

Date:	04/29/2018	Weather:		Coding:	RZMACP
MH#:	M-704-004	Owner:	NA	Len. Surveyed:	16.8
P.O.#:		Surveyor:	Jen Costello	Rim to Invert:	18.8
Customer:		Cert. #:	U-907-5518	Wall Material:	Concrete (reinforced)

Street:	Linda St. 41' North of Home Ave.	Project:	Hobart, IN
City:	Hobart, IN	GPS Northing:	41.53818512
Location:		GPS Easting:	-87.25004578
Drain Area:	Northeast	GPS Accuracy:	Nearest Meter
Cover Shape:	Circular	Evidence of Surcharge:	No
Cover Size:	22.5	Potential for Runoff:	None
Comments:

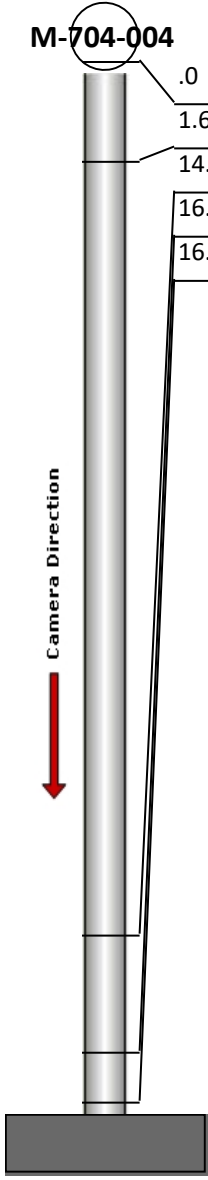
.0	MGO	General Observation	10	NA
	1.6	MGP	General Photo	26	NA
	14.1	SAV	Surface Aggregate Visible	65	S 3
	16.0	DAR	Deposits Attached Ragging	80	M 2
	16.8	MGO	General Observation	92	NA
