Manhole Inspection Report

Date:	04/29/2018	Weather:		Coding:	RZMACP
MH#:	M-704-008	Owner:	NA	Len. Surveyed:	16.7
P.O.#:		Surveyor:	Jen Costello	Rim to Invert:	18.2
Customer:		Cert. #:	U-907-5518	Wall Material:	Concrete (reinforced)

Street:	Cleveland Ave. 241' East of Michigan	Project:	Hobart, IN
City:	Hobart, IN	GPS Northing:	41.53617859
Location:		GPS Easting:	-87.25134277
Drain Area:	Northeast	GPS Accuracy:	Nearest Meter
Cover Shape:	Circular	Evidence of Surcharge:	No
Cover Size:	22.5	Potential for Runoff:	None
Comments:

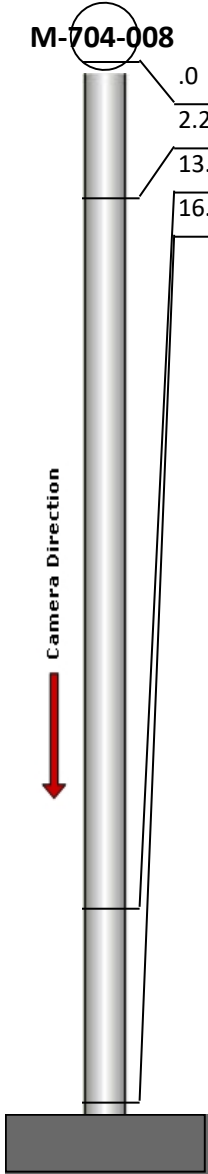
.0	MGO	General Observation	10	NA
	2.2	MGO	General Observation	28	NA
	13.6	IW	Infil Weeper	64	M 2
	16.7	MGO	General Observation	82	NA
