Manhole Inspection Report

Date:	05/16/2018	Weather:		Coding:	RZMACP
MH#:	M-704-019	Owner:	NA	Len. Surveyed:	4.5
P.O.#:		Surveyor:	Jen Costello	Rim to Invert:	4.7
Customer:		Cert. #:	U-907-5518	Wall Material:	Concrete (reinforced)

Street:	Michigan Ave. 403' South of South S	Project:	Hobart, IN
City:	Hobart, IN	GPS Northing:	2906729.141
Location:		GPS Easting:	2906729.141
Drain Area:	Northeast	GPS Accuracy:	Sub-Meter
Cover Shape:	Circular	Evidence of Surcharge:	No
Cover Size:	22.5	Potential for Runoff:	None
Comments:

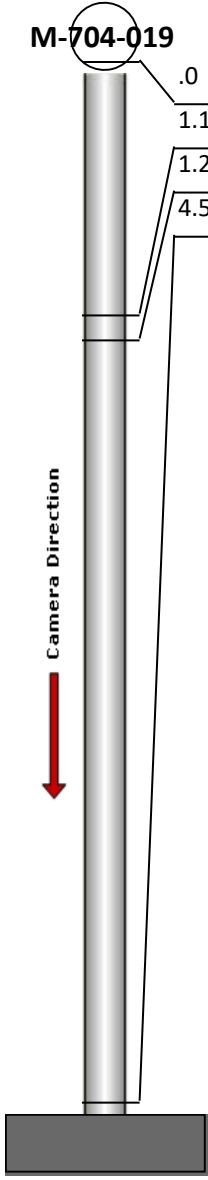
M-704-019				
	.0	MGP	General Photo	10	NA
	1.1	DB	Displaced Brick	24	S 3
	1.2	MGO	General Observation	37	NA
	4.5	MSA	Abandoned Survey	57	NA
