Manhole Inspection Report

Date:	05/01/2018	Weather:		Coding:	RZMACP
MH#:	M-704-032	Owner:	NA	Len. Surveyed:	8.9
P.O.#:		Surveyor:	Jen Costello	Rim to Invert:	9.7
Customer:		Cert. #:	U-907-5518	Wall Material:	Brick

Street:	Old Ridge Rd. 188' East of Lake Park	Project:	Hobart, IN
City:	Hobart, IN	GPS Northing:	41.53714371
Location:		GPS Easting:	-87.25906372
Drain Area:	North	GPS Accuracy:	Nearest Meter
Cover Shape:	Circular	Evidence of Surcharge:	No
Cover Size:	22.5	Potential for Runoff:	None
Comments:

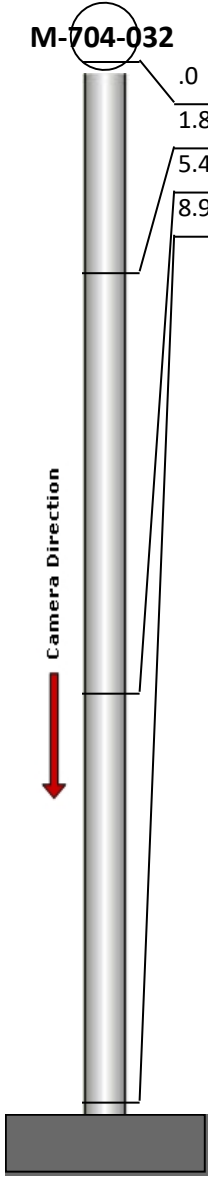
.0	MGP	General Photo	10	NA
	1.8	MGO	General Observation	27	NA
	5.4	OBP	Obstacle External Pipe or Cable	48	M 2
	8.9	MGO	General Observation	66	NA
