# Manhole Inspection Report

Date:	05/03/2018	Weather:		Coding:	RZMACP
MH#:	M-705-015	Owner:	NA	Len. Surveyed:	4.2
P.O.#:		Surveyor:	Jen Costello	Rim to Invert:	4.7
Customer:		Cert. #:	U-907-5518	Wall Material:	Brick

Street:	Intersection of 5th St. and Center St.	Project:	Hobart, IN
City:	Hobart, IN	GPS Northing:	2906550.36
Location:		GPS Easting:	2906550.36
Drain Area:	South	GPS Accuracy:	Sub-Meter
Cover Shape:	Circular	Evidence of Surcharge:	No
Cover Size:	22.5	Potential for Runoff:	None
Comments:

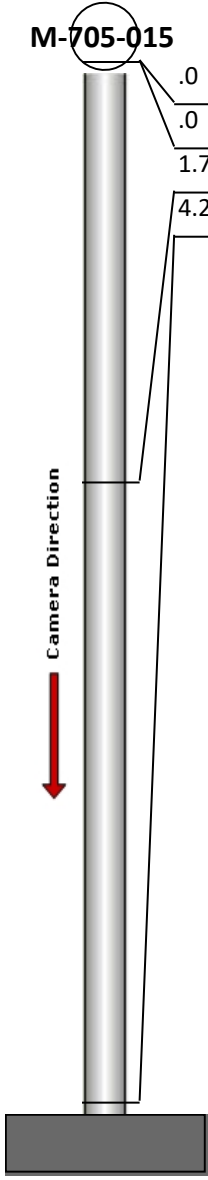
.0	MGP	General Photo	10	NA
	.0	DB	Displaced Brick	21	S 3
	1.7	MGO	General Observation	38	NA
	4.2	MGO	General Observation	56	NA
