Manhole Inspection Report

Date:	05/03/2018	Weather:		Coding:	RZMACP
MH#:	M-705-026	Owner:	NA	Len. Surveyed:	12.4
P.O.#:		Surveyor:	Jen Costello	Rim to Invert:	12.7
Customer:		Cert. #:	U-907-5518	Wall Material:	Concrete (reinforced)

Street:	Intersection of Main St. and Second	Project:	Hobart, IN
City:	Hobart, IN	GPS Northing:	41.53307724
Location:		GPS Easting:	-87.25546265
Drain Area:	South	GPS Accuracy:	Nearest Meter
Cover Shape:	Circular	Evidence of Surcharge:	No
Cover Size:	22.5	Potential for Runoff:	None
Comments:

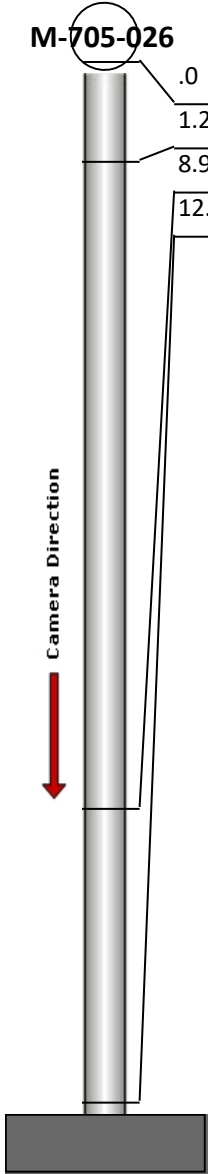
.0	MGP	General Photo	10	NA
	1.2	MGO	General Observation	26	NA
	8.9	RFJ	Roots Fine Joint	54	M 1
	12.4	MGO	General Observation	71	NA
