Manhole Inspection Report

Date:	05/03/2018	Weather:		Coding:	RZMACP
MH#:	M-705-029	Owner:	NA	Len. Surveyed:	7.3
P.O.#:		Surveyor:	Jen Costello	Rim to Invert:	7.8
Customer:		Cert. #:	U-907-5518	Wall Material:	Concrete (reinforced)

Street:	Center St. 258' North of 5th St.	Project:	Hobart, IN
City:	Hobart, IN	GPS Northing:	2906447.667
Location:		GPS Easting:	2906447.667
Drain Area:	South	GPS Accuracy:	Sub-Meter
Cover Shape:	Circular	Evidence of Surcharge:	No
Cover Size:	22.5	Potential for Runoff:	None
Comments:

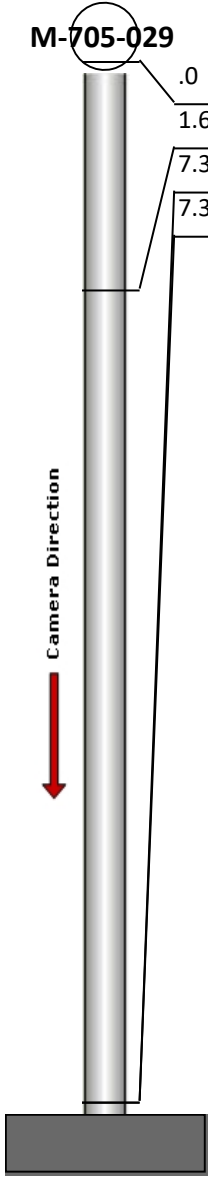
M-705-029				
	.0	MGP	General Photo	10	NA
	1.6	MGO	General Observation	26	NA
	7.3	DSF	Deposits Settled Fine	51	M 2
	7.3	MGO	General Observation	62	NA
