Manhole Inspection Report

Date:	05/03/2018	Weather:		Coding:	RZMACP
MH#:	M-705-030	Owner:	NA	Len. Surveyed:	7.5
P.O.#:		Surveyor:	Jen Costello	Rim to Invert:	9.0
Customer:		Cert. #:	U-907-5518	Wall Material:	Concrete (reinforced)

Street:	Center St. 228' South of 4th St.	Project:	Hobart, IN
City:	Hobart, IN	GPS Northing:	2906359.037
Location:		GPS Easting:	2906359.037
Drain Area:	South	GPS Accuracy:	Sub-Meter
Cover Shape:	Circular	Evidence of Surcharge:	No
Cover Size:	22.5	Potential for Runoff:	None
Comments:

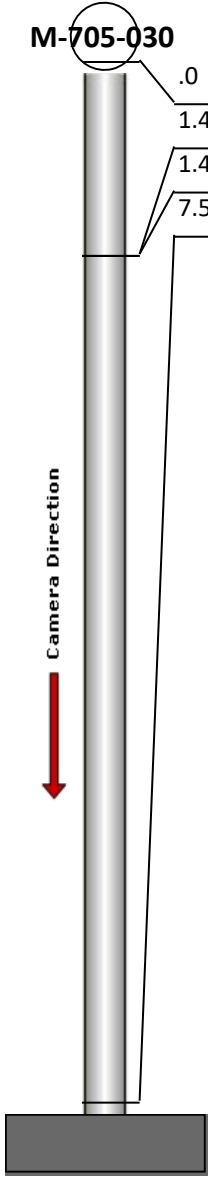
M-705-030				
	.0	MGP	General Photo	10	NA
	1.4	CL	Crack Longitudinal	25	S 2
	1.4	MGO	General Observation	38	NA
	7.5	MGO	General Observation	63	NA
