Manhole Inspection Report

Date:	05/03/2018	Weather:		Coding:	RZMACP
MH#:	M-705-034	Owner:	NA	Len. Surveyed:	9.6
P.O.#:		Surveyor:	Jen Costello	Rim to Invert:	9.8
Customer:		Cert. #:	U-907-5518	Wall Material:	Concrete (reinforced)

Street:	Center St. 195' South of Second St.	Project:	Hobart, IN
City:	Hobart, IN	GPS Northing:	41.53271866
Location:		GPS Easting:	-87.2538681
Drain Area:	South	GPS Accuracy:	Nearest Meter
Cover Shape:	Circular	Evidence of Surcharge:	No
Cover Size:	22.5	Potential for Runoff:	None
Comments:

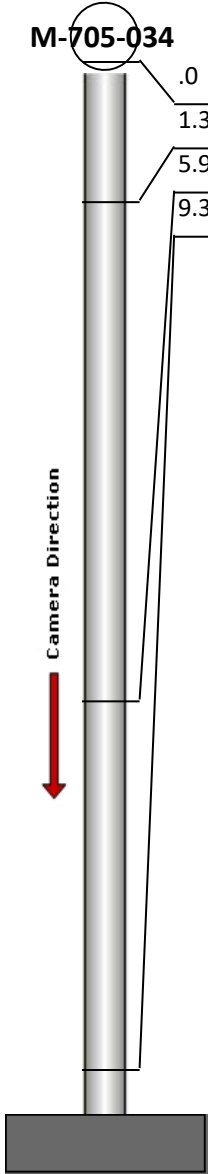
.0	MGP	General Photo	10	NA
	1.3	MGO	General Observation	26	NA
	5.9	RFJ	Roots Fine Joint	48	M 1
	9.3	MGO	General Observation	66	NA
