Manhole Inspection Report

Date:	05/04/2018	Weather:		Coding:	RZMACP
MH#:	M-705-049	Owner:	NA	Len. Surveyed:	8.6
P.O.#:		Surveyor:	Jen Costello	Rim to Invert:	9.4
Customer:		Cert. #:	U-907-5518	Wall Material:	Concrete (reinforced)

Street:	4th St. 45' West of New St.	Project:	Hobart, IN
City:	Hobart, IN	GPS Northing:	2906739.059
Location:		GPS Easting:	2906739.059
Drain Area:	South	GPS Accuracy:	Sub-Meter
Cover Shape:	Circular	Evidence of Surcharge:	No
Cover Size:	22.5	Potential for Runoff:	None
Comments:

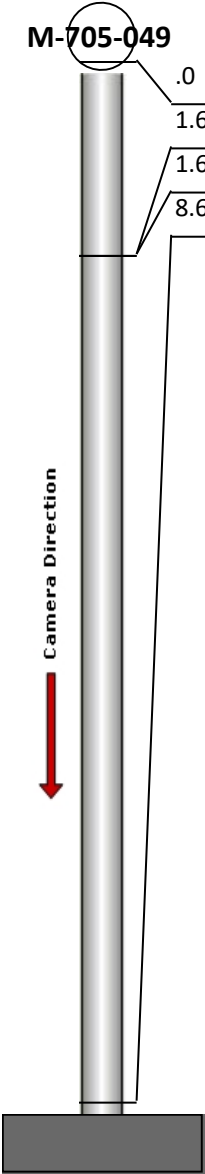
Position	Code	Observation	Video (sec)	Grade
<div> <div>M-705-049</div>

</div>	.0	MGP	General Photo	10	NA
	1.6	VC	Vermin Cockroach	25	M 1
	1.6	MGO	General Observation	38	NA
	8.6	MGO	General Observation	65	NA
