Manhole Inspection Report

Date:	05/03/2018	Weather:		Coding:	RZMACP
MH#:	M-705-053	Owner:	NA	Len. Surveyed:	4.8
P.O.#:		Surveyor:	Jen Costello	Rim to Invert:	4.9
Customer:		Cert. #:	U-907-5518	Wall Material:	Brick

Street:	3rd St. 143' East of Park St.	Project:	Hobart, IN
City:	Hobart, IN	GPS Northing:	41.53120804
Location:		GPS Easting:	-87.25725555
Drain Area:	West	GPS Accuracy:	Nearest Meter
Cover Shape:	Circular	Evidence of Surcharge:	No
Cover Size:	22.5	Potential for Runoff:	None
Comments:

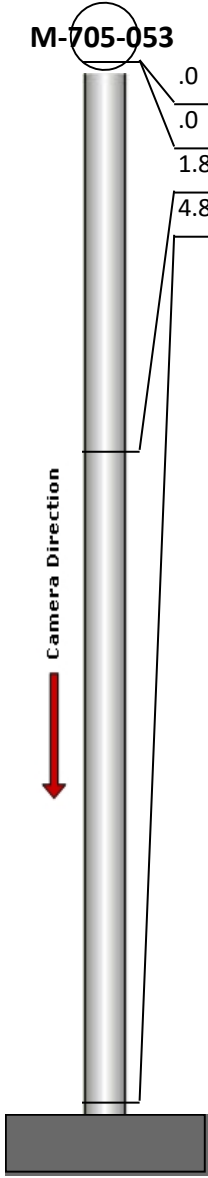
M-705-053				
	.0	MGP	General Photo	10	NA
	.0	DAE	Deposits Attached Encrustation	21	M 2
	1.8	MGO	General Observation	38	NA
	4.8	DSGV	Deposits Settled Gravel	58	M 5
