Manhole Inspection Report

Date:	05/04/2018	Weather:		Coding:	RZMACP
MH#:	M-705-059	Owner:	NA	Len. Surveyed:	19.0
P.O.#:		Surveyor:	Jen Costello	Rim to Invert:	24.3
Customer:		Cert. #:	U-907-5518	Wall Material:	Concrete (reinforced)

Street:	171' East of Ridge Road. North of M	Project:	Hobart, IN
City:	Hobart, IN	GPS Northing:	2905607.022
Location:		GPS Easting:	2905607.022
Drain Area:	South	GPS Accuracy:	Sub-Meter
Cover Shape:	Circular	Evidence of Surcharge:	No
Cover Size:	22.5	Potential for Runoff:	None
Comments:

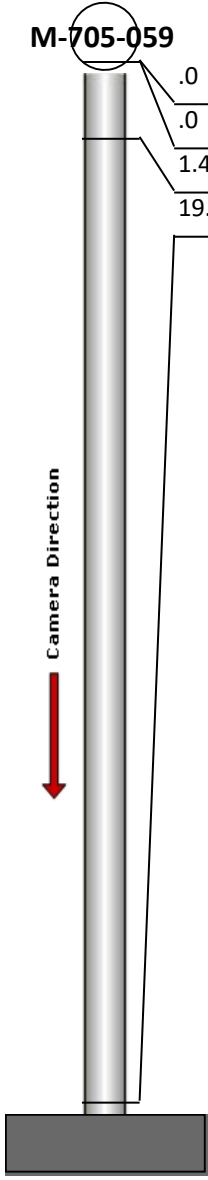
.0	MGP	General Photo	10	NA
	.0	SAV	Surface Aggregate Visible	21	S 3
	1.4	MGO	General Observation	37	NA
	19.0	MGO	General Observation	85	NA
