Manhole Inspection Report

Date:	05/06/2018	Weather:		Coding:	RZMACP
MH#:	M-705-066	Owner:	NA	Len. Surveyed:	13.3
P.O.#:		Surveyor:	Jen Costello	Rim to Invert:	14.5
Customer:		Cert. #:	U-907-5518	Wall Material:	Concrete (reinforced)

Street:	In Park. 255' Southeast of Cleveland	Project:	Hobart, IN
City:	Hobart, IN	GPS Northing:	2905053.598
Location:		GPS Easting:	2905053.598
Drain Area:	West	GPS Accuracy:	Sub-Meter
Cover Shape:	Circular	Evidence of Surcharge:	No
Cover Size:	22.5	Potential for Runoff:	None
Comments:

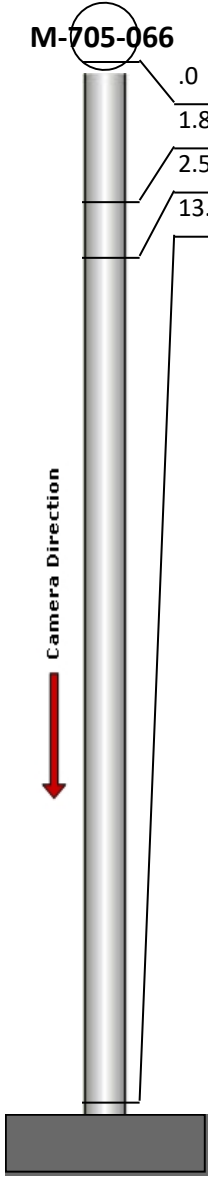
.0	MGP	General Photo	10	NA
	1.8	FC	Fracture Circumferential	25	S 2
	2.5	MGO	General Observation	40	NA
	13.3	MGO	General Observation	75	NA
