Manhole Inspection Report

Date:	05/04/2018	Weather:		Coding:	RZMACP
MH#:	M-705-076	Owner:	NA	Len. Surveyed:	6.7
P.O.#:		Surveyor:	Jen Costello	Rim to Invert:	7.8
Customer:		Cert. #:	U-907-5518	Wall Material:	Concrete (reinforced)

Street:	Old Ridge Road. West of Main L/S.	Project:	Hobart, IN
City:	Hobart, IN	GPS Northing:	41.53582001
Location:		GPS Easting:	-87.25637817
Drain Area:	West	GPS Accuracy:	Nearest Meter
Cover Shape:	Circular	Evidence of Surcharge:	No
Cover Size:	22.5	Potential for Runoff:	None
Comments:

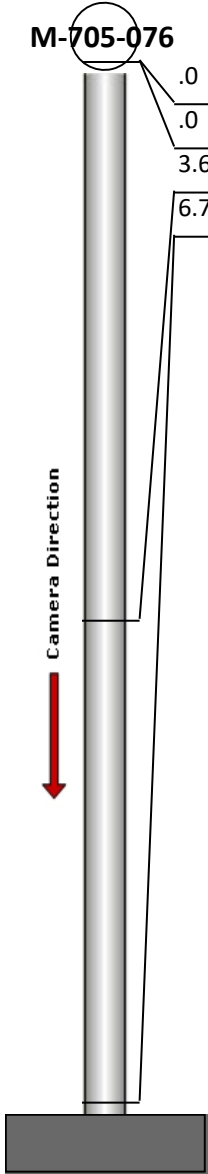
.0	MGP	General Photo	10	NA
	.0	FM	Fracture Multiple	21	S 4
	3.6	OBZ	Obstacle Other	40	M 2
	6.7	MGO	General Observation	57	NA
