Manhole Inspection Report

Date:	05/03/2018	Weather:		Coding:	RZMACP
MH#:	M-705-086	Owner:	NA	Len. Surveyed:	4.3
P.O.#:		Surveyor:	Jen Costello	Rim to Invert:	4.8
Customer:		Cert. #:	U-907-5518	Wall Material:	Concrete (reinforced)

Street:	South Side of 3rd St. 246' West of M	Project:	Hobart, IN
City:	Hobart, IN	GPS Northing:	41.53172684
Location:		GPS Easting:	-87.25563049
Drain Area:	South	GPS Accuracy:	Nearest Meter
Cover Shape:	Circular	Evidence of Surcharge:	No
Cover Size:	22.5	Potential for Runoff:	None
Comments:

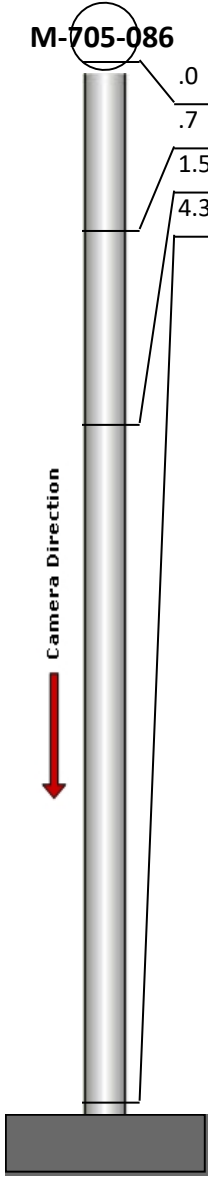
.0	MGO	General Observation	10	NA
	.7	SAV	Surface Aggregate Visible	23	S 3
	1.5	MGO	General Observation	37	NA
	4.3	MGO	General Observation	56	NA
