Manhole Inspection Report

Date:	04/24/2018	Weather:		Coding:	RZMACP
MH#:	M-706-007.2	Owner:	NA	Len. Surveyed:	9.0
P.O.#:		Surveyor:	Jen Costello	Rim to Invert:	9.0
Customer:	8.7	Cert. #:	U-907-5518	Wall Material:	Brick

Street:	Intersection of 9th St. and Linda St.	Project:	Hobart, IN
City:	Hobart, IN	GPS Northing:	0.0
Location:		GPS Easting:	0.0
Drain Area:	Southeast	GPS Accuracy:	Nearest Meter
Cover Shape:	Circular	Evidence of Surcharge:	No
Cover Size:	22.5	Potential for Runoff:	None
Comments:

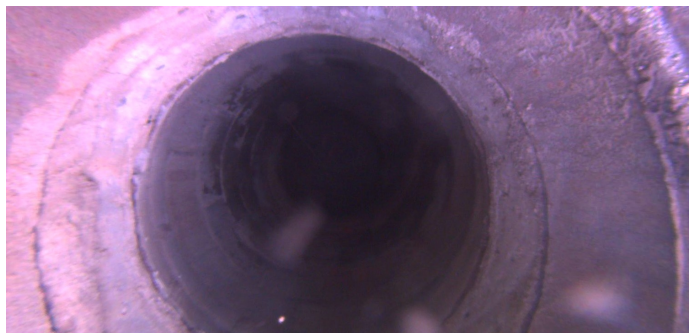
Code: **MGO**
Description: **General Observation**

Distance (ft): **.0**
Structural Grade: **0**
O&M Grade: **0**
Clock Start/From:
Clock To:
1st Value:
2nd Value:
Value Percent:
Step: **NO**
Remarks: **access mh**

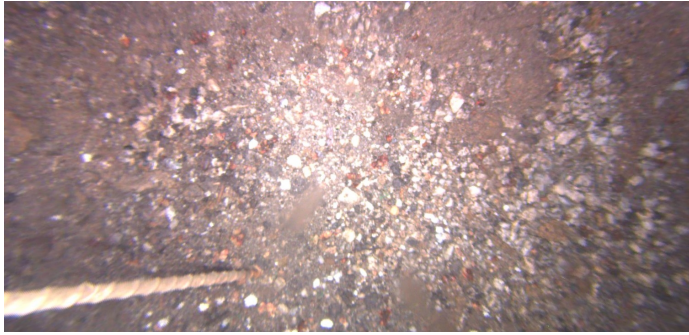
Code:	MGO
Description:	General Observation
Distance (ft):	9.0
Structural Grade:	0
O&M Grade:	0
Clock Start/From:	
Clock To:	
1st Value:	
2nd Value:	
Value Percent:	
Step:	NO
Remarks:	end survey
