Manhole Inspection Report

Date:	04/23/2018	Weather:		Coding:	RZMACP
MH#:	M-706-008.3	Owner:	NA	Len. Surveyed:	8.3
P.O.#:		Surveyor:	Jen Costello	Rim to Invert:	8.1
Customer:	8.7	Cert. #:	U-907-5518	Wall Material:	Brick

Street:	Intersection of 9th St. and Garfield S	Project:	Hobart, IN
City:	Hobart, IN	GPS Northing:	0.0
Location:		GPS Easting:	0.0
Drain Area:	Southeast	GPS Accuracy:	Nearest Meter
Cover Shape:	Circular	Evidence of Surcharge:	No
Cover Size:	22.5	Potential for Runoff:	None
Comments:

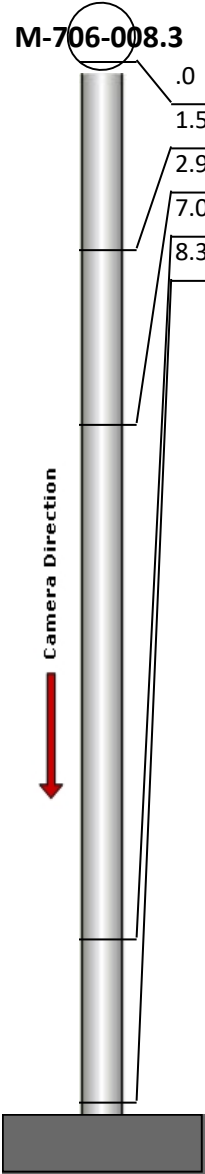
.0	MGO	General Observation	10	NA
	1.5	MGP	General Photo	26	NA
	2.9	MGO	General Observation	42	NA
	7.0	DSF	Deposits Settled Fine	61	M 2
	8.3	MGO	General Observation	75	NA
